# STAATSOPER UNTER DEN LINDEN BERLIN

Martijn Vercammen Peutz, Mook, Netherlands, m.vercammen at peutz.nl.  
 Margriet Lautenbach Peutz, Zoetermeer, Netherlands, m.lautenbach at peutz.nl

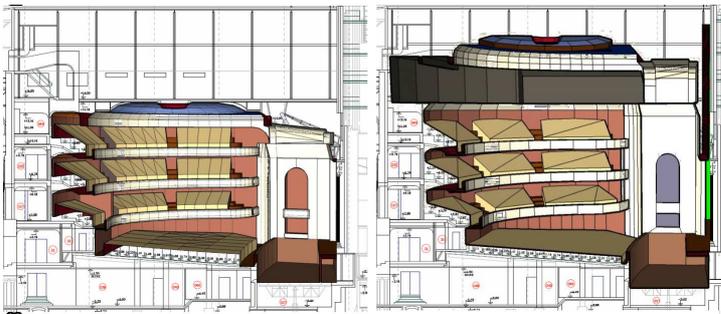
Figure 4 shows the 3D models of the existing hall and the final design in the longitudinal section of the building. It was possible to achieve 9300 m<sup>3</sup>. With closed fire curtain (FC) an average RT of 1,6 s. was calculated. With open curtain it depends on the stage set being used. With the set that was on stage during the measurements in the existing situation, the resulting RT's are a bit lower (fig. 5).

Figure 4. acoustic calculation model overlaying the longitudinal section of the hall. Left: existing before 2010, right: final design.

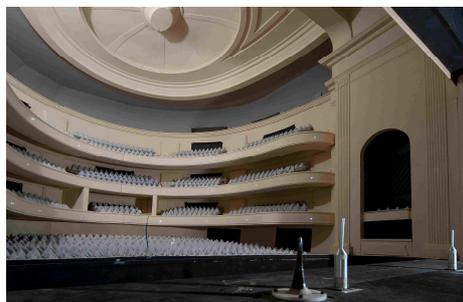
In order to incorporate the wave character of sound, the initial research through calculations was extended with a scale model. A scale model 1:10 was made, details with size 10 cm, in many cases also smaller, were taken into account. Reflecting surfaces are wood with varnish, audience by pyramid foam, simulating an occupied hall, see figure 6.

Figure 6. Scale model 1:10 with the raised ceiling and reverberation gallery. High frequency source and microphone with pre-amplifier in foreground.

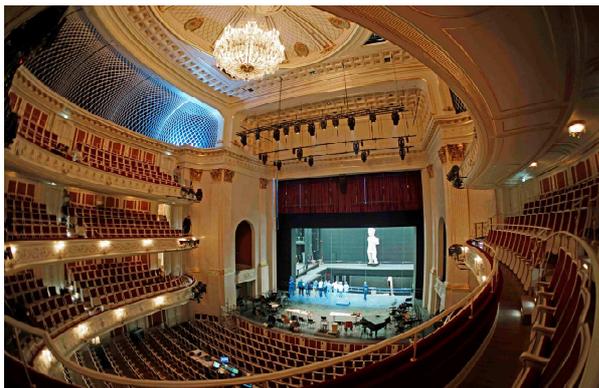
Figure 14. Photo of the renewed opera hall, september 2017

In september 2017 the hall was almost finished, see fig. 14. Before the first rehearsal, acoustic measurements were performed. The hall was measured without and with audience simulation with special curtains, see fig. 15. Measurements were performed with fire curtain (FC) open and closed. Also the situation for symphonic concerts, with orchestra shell on stage, was measured. Measurements of the RT were done with interrupted noise and with a 9 mm pistol, mainly for the 63 Hz octav band. Impulse response measurements were done with an MLS signal and MLSSA computer, and with an omnidirectional sound source<sup>8</sup>.

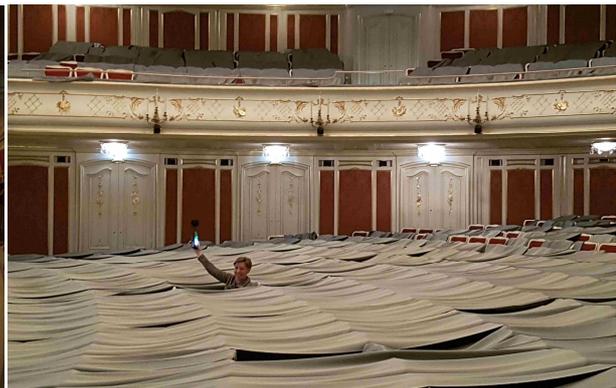
Figure 15. Stalls with audience simulation (curtains) and one of the authors with a sound level meter.

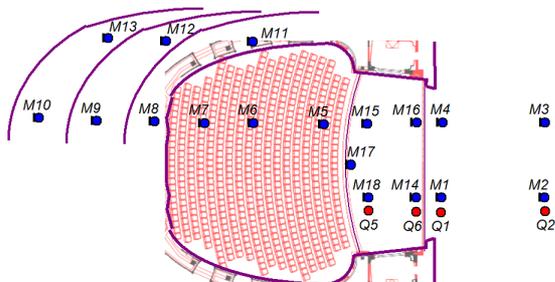
From these data the different parameters, such as clarity were derived. The 1 m positions were used to determine the strength. Figure 16 shows the source and receiver positions.

Figure 16. Sources (in red) and receivers (in blue). Balconies are schematic. Not shown: source position 7 in the pit (under Q1).
